Post-event field observations in the İzmir–Sığacık village for the tsunami of the 30 October 2020 Samos (Greece) M_w 6.9 earthquake

Abstract

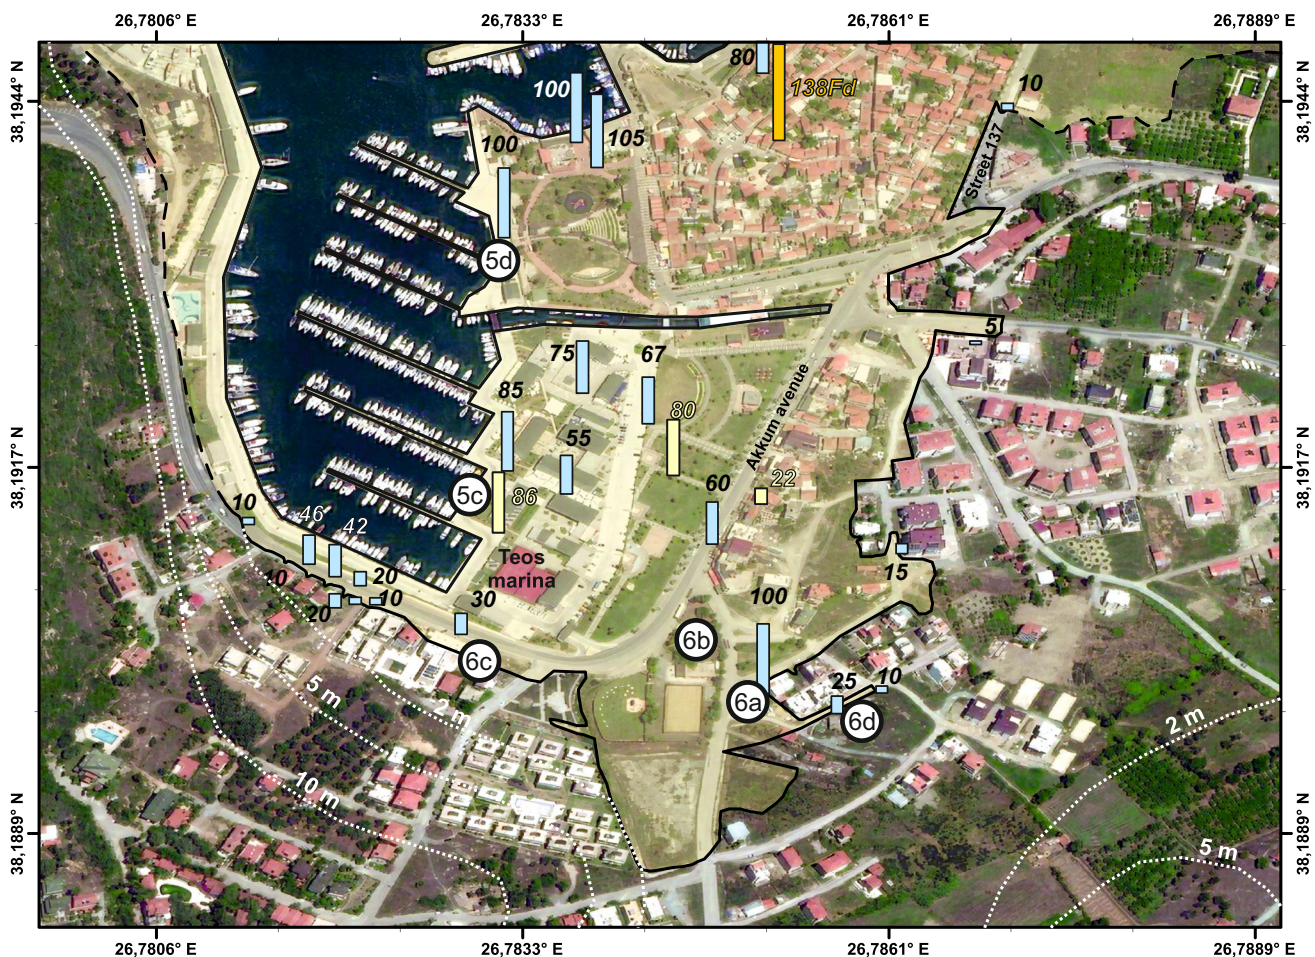
Fig. 3 The columns represent the flow depth measurements. Yellow, orange, grey and blue columns are from Yalçiner et al. (2020a, b), Doğan et al. (2020) and this study, respectively. The yellow shading corresponds to the inundated area. White circles indicate figure

locations. White dotted lines are elevation contours. The inundation is controlled by the high topography at the south; therefore, the west of the marina was inundated for 30–40 m, while in the east the sea water reached nearly a distances of 300 ± 1 m

In the south, near the Teos marina, the topography is moderately steep and the marina is enclosed with 50–200-cm-high walls (Fig. 3). Here, the waves overtopped the marina walls and penetrated 30 to 40 ± 1 m inland. The maximum flow depth was limited to 46 ± 1 cm along the main road outside the marina. Here, the flow drifted the boats, debris and garbage containers (Figs. 4, 5c). Additional photographs of inundation traces in this area are available in Supplementary file (Figs. s1–s6). Towards SE, the topography flattens, here the tsunami travelled 277 ± 2 m inland and occupied a large area (Fig. 3). The shops along the Akkum avenue (which runs parallel to the coast), the village clinic, and a park were inundated (Figs. 3, 5a, b). A shop owner claimed 100 ± 10 cm flow depth in this area (Fig. s7). Little fishes have been observed in the remaining ponds of the park and surrounding terrain (Fig. 5a, s8).

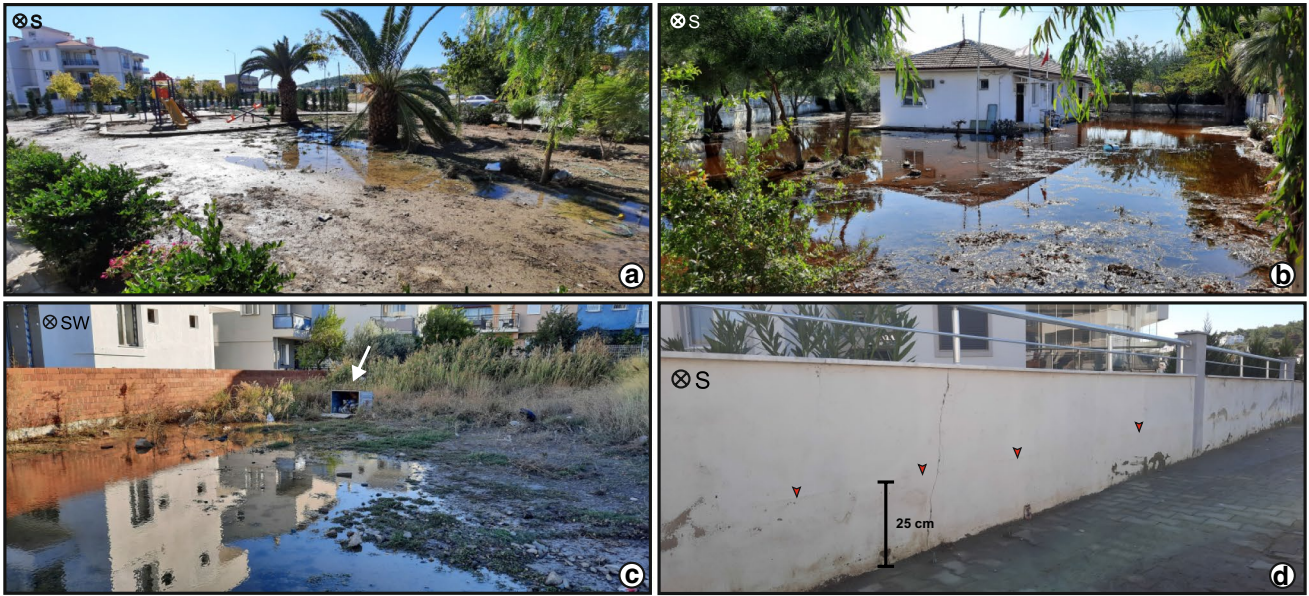
Fig. 5 **a** Ponds in a park South of Sığacık, 100 cm flow depth at a nearby store, **b** the village clinic is located south of the marina and was inundated. **c** The flow drifted wares such as garbage contain-

ers, photograph from the south of the marina. **d** Mud traces on walls allowed determining the distribution and size of the inundation in the southern parts of Sığacık villages. See Fig. 9 for locations

Towards the north, the tsunami affected a wider area. Flow depths of 105–55 cm were documented along the facilities around the Teos marina (Figs. s7–s10). The flooding drifted large tree pots, tables and other furniture of restaurants. The entire NE-trending main road (Akkum avenue) was inundated. Smartphone recordings show several cars drifting in this area. A coffee-shop owner along the road claimed 60 ± 10 cm flow height. The inundation varied between 270 and 330 m ± 2 m in this part of the village. Several mud traces on walls allowed mapping this area (Fig. 5d).

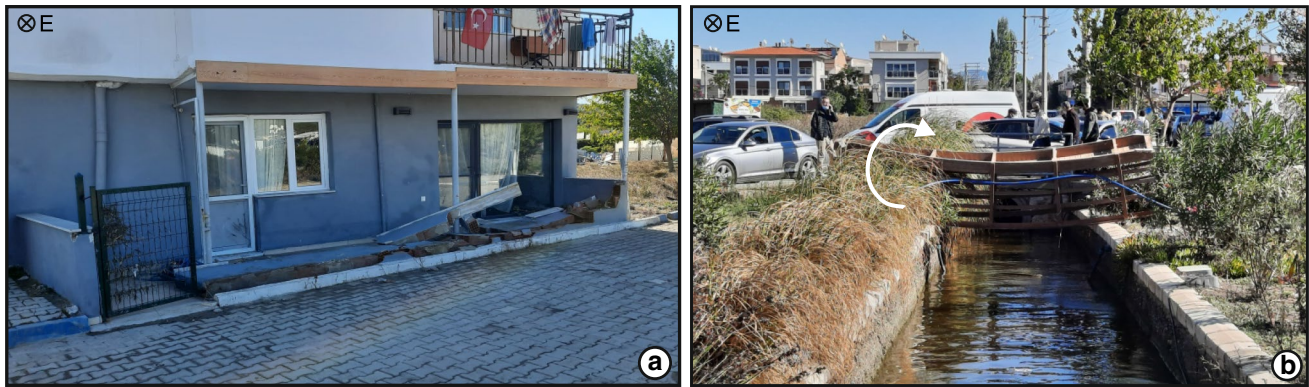
Fig. 7 **a** A 80-cm-high N–S-oriented wall facing the shore did not resist the tsunami destroyed walls. **b** A bridge on the E–W was drifted and toppled by the waves

(tables, chairs, etc.) and caused one fatality. The 2–4-m-high walls of the old town served as a blockage and protected the south-east area outside of the old town; therefore, the inundation was limited to < 200 ± 2 m in this part of Sığacık. Eyewitnesses report a flow depth of 10 cm along the Street 137 (Fig. 3). The coastal section further north is highly flat, low ($h < 1$ m) and unoccupied (Fig. 6). A limited amount of structures allowed measuring the flow depth, which ranged from 88 to 120 cm. E–W-trending channels facilitated the travel of the tsunami further inland. The waves toppled a bridge across one of these channels (Fig. 7b). The tsunami was sufficiently strong to topple 50- to 80-cm-high walls (Figs. 7a, 8a, d, s16).

20–30-cm-thick) received directly the tsunami and collapsed (Figs. 7, 8).

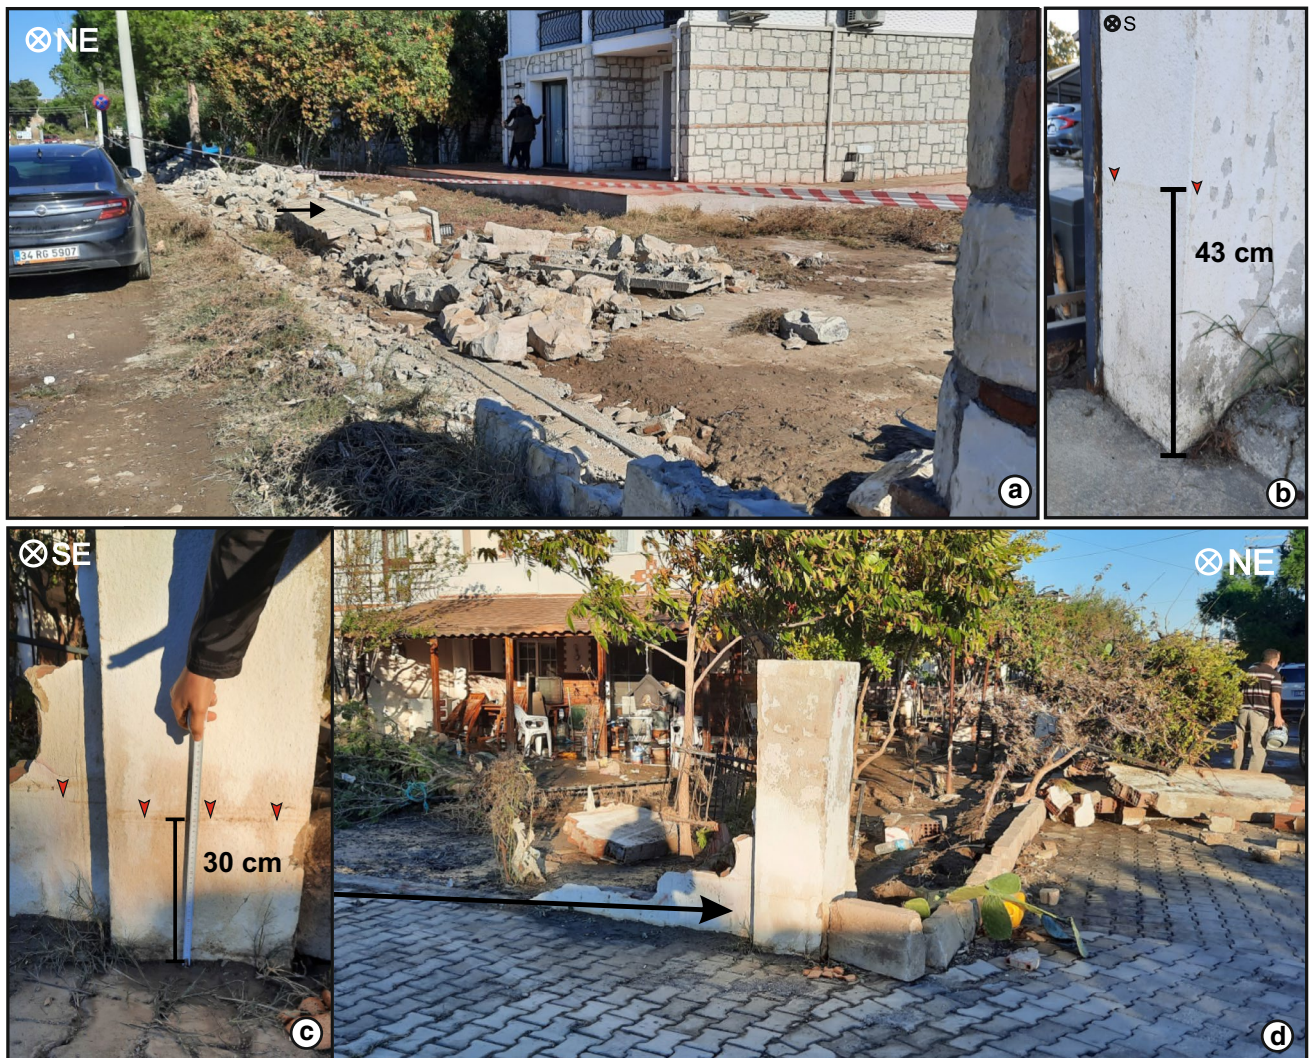
Fig. 8 Approximately N–S-oriented walls collapsed when hit by the tsunami with a flow depth of 30–40 cm at the northern part of Sığacık
